CITY OF BALTIMORE SMOKE TESTING OBSERVATION SUMMARY LOW LEVEL SEWERSHED

BALTIMORE CITY PROJECT 1029 REI/DRAYCO

Unique Test ID: 577 Date: 08/27/2008 Basin: LL - 44 Manhole ID: S19M__002MH Defect No: OB01 Supervisor: E.R. Crew: 04 Dye Test Recommended: N

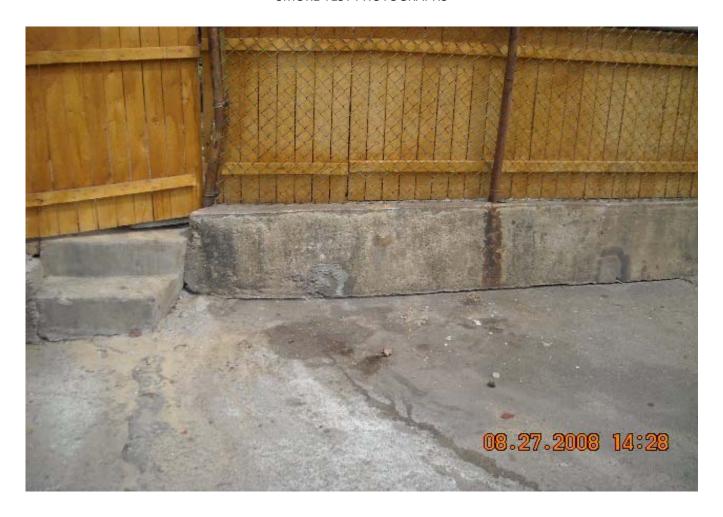
Photograph No: OB01-01 Filename: 1029-577_OB01-01.jpg

Location: 468 S. BENTALOU ST.

Source Type: 02 Service Line Sector: 02 Private

Location: 12 Alley Severity: 03 Moderate Drainage Area: 16

Comments: SMOKE IS COMING FROM BOTTOM OF CONCRETE SLAB.
